## **BADANIE PRZYCZYN USZKODZEŃ ZĘBÓW PRZEKŁADNI**

## **INVESTIGATION OF CAUSES CONCERNING TOOTH DAMAGE IN THE GEARBOXES**

### 3. Damage of bevel gear of small hydropower hydrogenerator

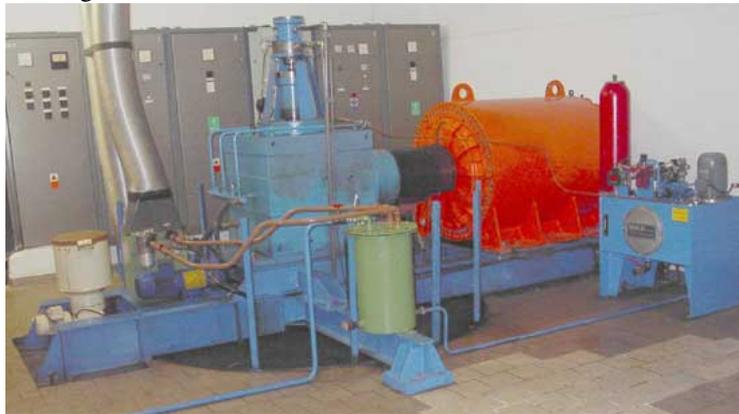
Figure 1. The small hydroelectric (power) plant

This chapter is devoted to damage teeth in small hydro generator of small hydroelectric (power) plant (Fig.1). After 10 years of activity is reflected increased noise. By measuring the vibration frequency analysis and subsequent hydro-generator which evaluated the mechanical vibration of rolling bearings and bevel gear has been found to be an error teeth of gear. After removing the gearbox is determining the extent of damage.

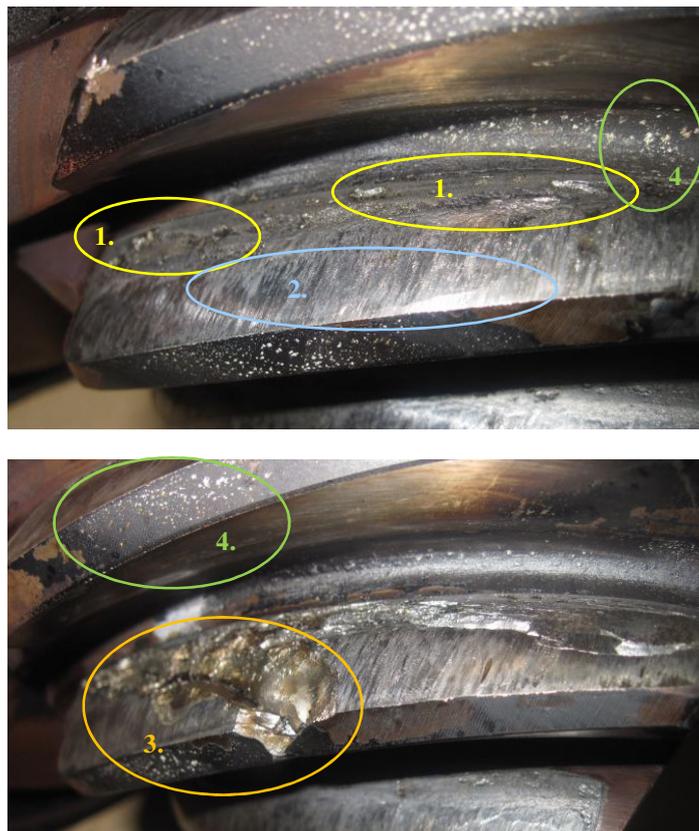
Figure 2. Damage of bevel pinion

Damage to the bevel pinion gear (Fig. 2) can be divided into four categories:

1. Near the foot of the tooth to a height of  $\frac{1}{3}$  to  $\frac{1}{2}$  tooth there are distinct, very large and distinct wells along the entire tooth length at each pinion tooth. This is called pitting.
2. Damage to the tooth flanks of the pitch to the head of the tooth vertical grooves that go over the heads of the tooth towards the tooth root belongs to damage teeth sticking.
3. Damage to one bevel pinion tooth fracture.
4. Damage to the tooth tip and tooth root has elements of abrasive wear.

Each tooth of bevel pinion is damaged by the pitting (Fig. 2 - type 1), damage to the tooth flanks of the pitch to the head of the tooth vertical grooves (Fig. 2 - type 2) and abrasive wear (Fig. 2 - type 4). Only one tooth is damaged by fracture.

Pitting is a manifestation of superficial fatigue. The damage is manifested by the removal of metal particles and the formation of cavities (wells). Pitting aren't due to wear, but due to surface and under surface tension due to the repeated effects of forces. The load level has effects at the surface pressure value. High flank pressure can succeed pitting cracks but, at the same time, it can eliminate lubricant and succeed sliding wear, which eliminates initial cracks. For this reason, better conditions for pitting development exist if the contact stress is not much higher than the endurance limit.

Influences that lead to it are varied, may be an inappropriate design (not suitable shape or size), inappropriate material (solid poorly or insufficiently tough), the error in the manufacture or assembly (indentations caused by stress due to improper technology) or the influence of temporal changes material properties (fatigue). So extensive damage to the gears could be prevented shutdown of the machine when the first increase in noise transfer and subsequent correction of errors that can be detected by checking the status gear already at this stage.

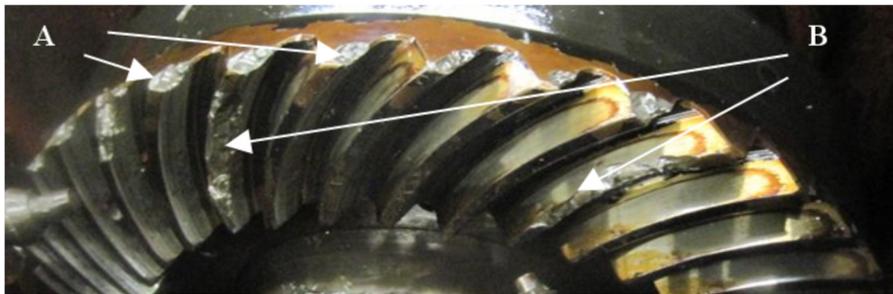
*Figure 3. Tooth fracture on the bevel gear wheel*

A bevel gear (rim) there was extensive damage to tooth fracture. All teeth are damaged, or not to leave one is intact, and we can distinguish two types of fractures (Fig. 3). Corner tooth fracture (A), this fracture is damaged every tooth cone wreath. Fold in the middle of the tooth face width (B), so only a few were damaged teeth.

Fatigue failure starts at the tooth surface and tensile stress fracture has two distinctive parts - fatigue (fine-grained) and power (crystalline, rough). Fatigue failure may also start working on the side of the tooth, causing the cracks after sanding.

Fracture surface static fracture is approximately equal and perpendicular to the direction of tension. Its surface is grainy, rough, coarse or subtle, depending on the grain size of the material. Because it was breaking open only part of the tooth can be an unbalanced tooth. This may be caused by improper tooth meshing, which could be caused by assembly (wheel bearings) gearbox, improper storage shafts and thereby excite vibrations, etc.

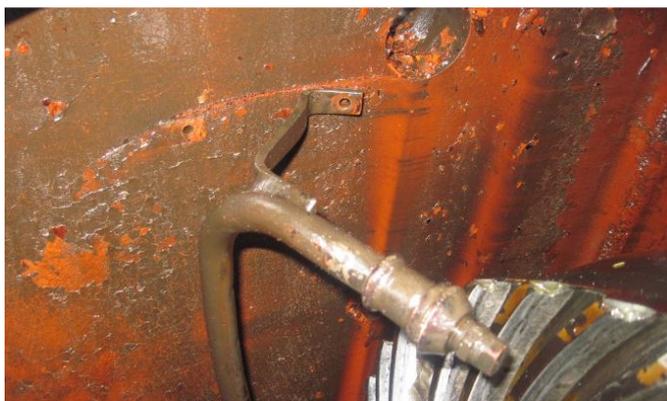
*Figure 4. Error primer coating gearbox*

For flawless operation must be fulfilled to ensure lubrication has been fluid friction, if these conditions are not met leads to tooth wear and time to seizure. In this case the seizure was caused by impurities in the lubricant. In case of insufficient lubrication, respectively due to impurities in the oil occurs to metal contact between the tooth flanks, which leads to micro weld and then splintering due to the relative motion tangential to the surface. This is explained in the holes of the head towards the tooth spacing. Impurities in the oil are due to peeling paint surface inside the gearbox and coat gears (Fig.4).

The damage was due to a combination of several causes. The first is application of inappropriate coating (prescription or non-compliance with protective coating applications) inside the gearbox. He caused the contamination in lubricants and defective lubrication of the gearing. Insufficient lubrication resulted in damage to the tooth flanks contact pitting. Effect of external or internal stresses which exceed the ultimate strength or fatigue strength of the material led to fracture teeth. If the material is brittle, explodes and arise cracks or break of tooth.
